EastLink Ventilation Stack Emission Monitoring Report July 2021

Golder Associates Pty Ltd

097613024-085-R-Rev0

October 2021

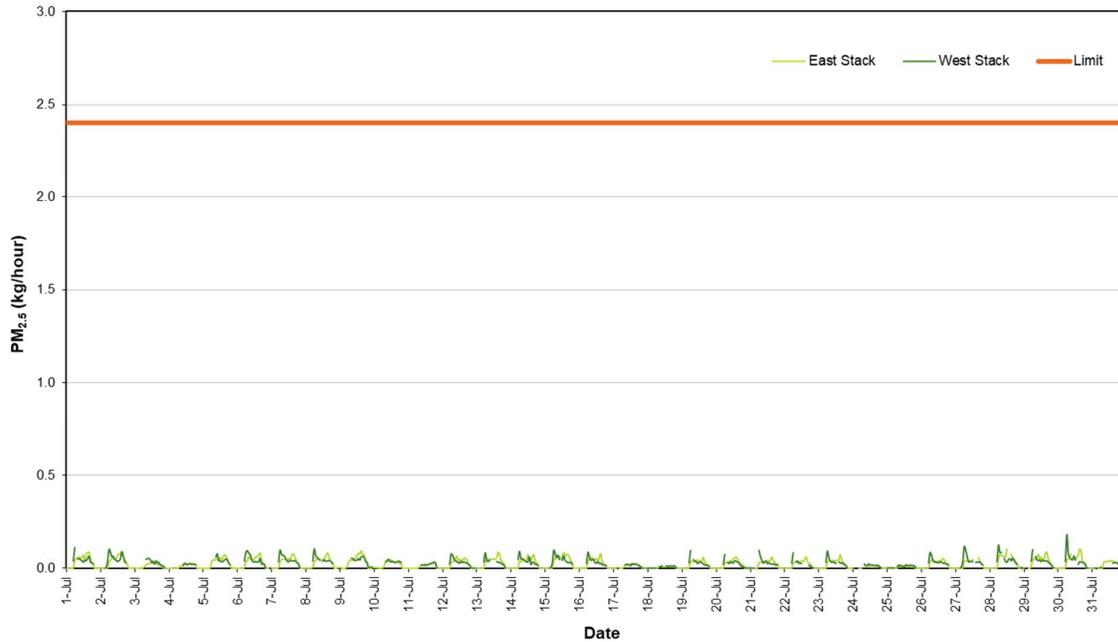
Figure 2: PM_{2.5} Mass Rate (1 Hour Average)

PM_{2.5} (1 hour average) mass rate of emission statistics for the reporting period are given in Table 4. A plot of PM_{2.5} (1 hour average) mass rate of emission for the reporting period is presented in Figure 2.

Station	PM _{2.5} Mass Rate (kg/h) (1 Hour Average)						
	Maximum	99 th	98 th	95 th	90 th	75 th	50 th
Eastern	0.11	0.086	0.081	0.072	0.062	0.043	0.016
Western	0.18	0.10	0.095	0.082	0.062	0.040	0.029

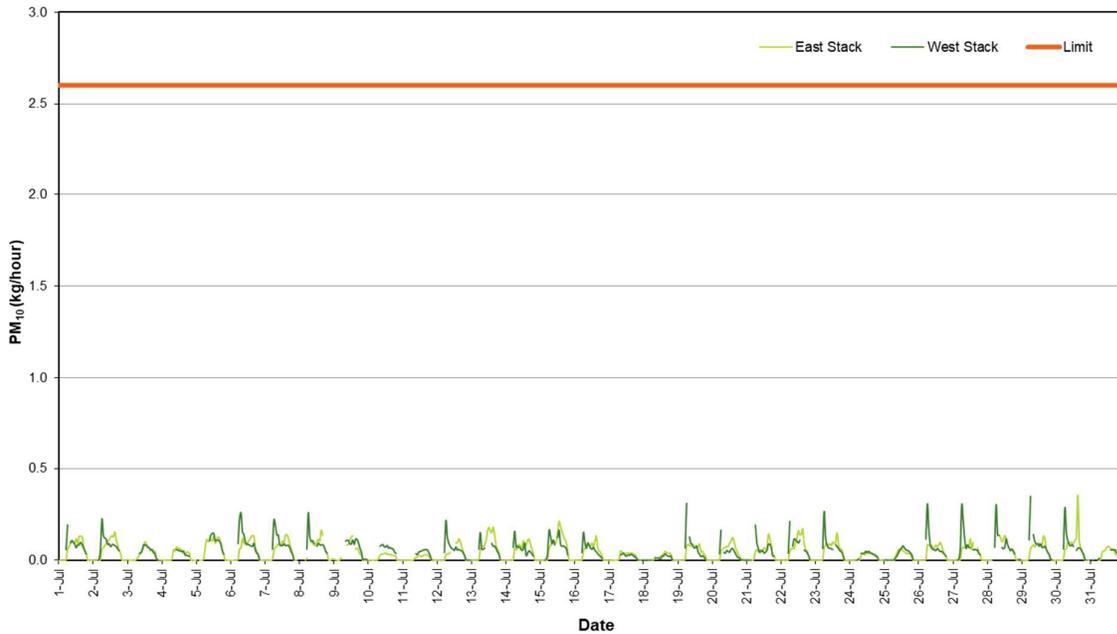
Figure 3: PM₁₀ Mass Rate (1 Hour Average)

PM₁₀ (1 hour average) mass rate of emission statistics for the reporting period are given in Table 5. A plot of PM₁₀ (1 hour average) mass rate of emission for the reporting period is presented in Figure 3.

Station	PM ₁₀ Mass Rate (kg/h) (1 Hour Average)						
	Maximum	99 th	98 th	95 th	90 th	75 th	50 th
Eastern	0.36	0.16	0.15	0.13	0.11	0.077	0.032
Western	0.35	0.29	0.24	0.16	0.12	0.084	0.057

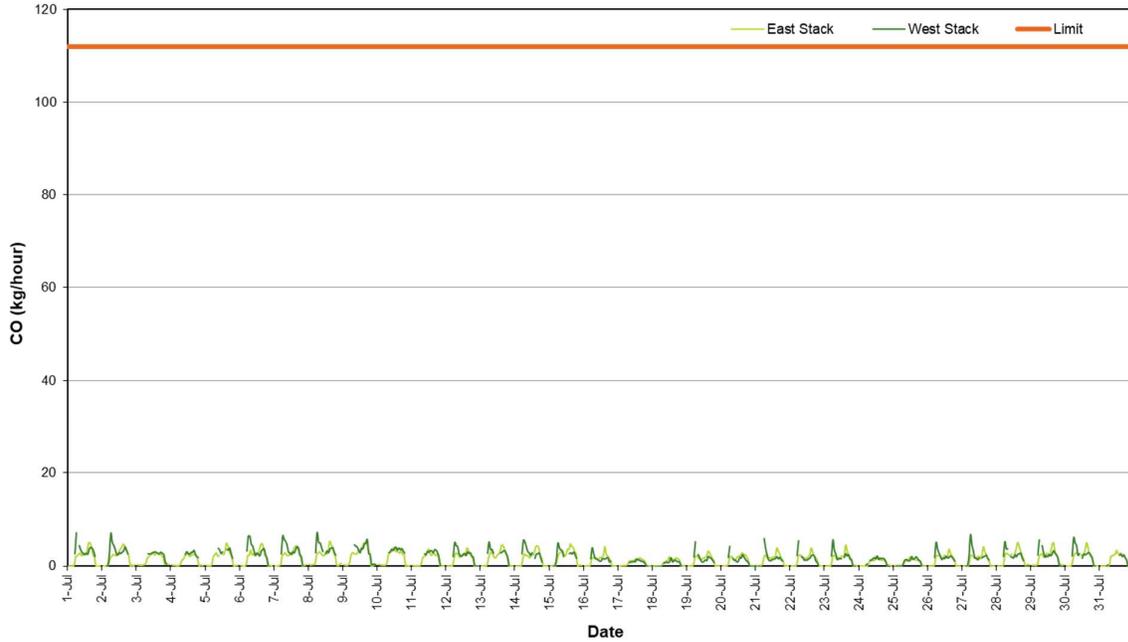
Figure 4: Carbon Monoxide Mass Rate (1 Hour Average)

Carbon monoxide (1 hour average) mass rate of emission statistics for the reporting period are given in Table 6. A plot of carbon monoxide (1 hour average) mass rate of emission for the reporting period is presented in Figure 4.

Station	Carbon Monoxide Mass Rate (kg/h) (1 Hour Average)						
	Maximum	99 th	98 th	95 th	90 th	75 th	50 th
Eastern	5.3	5.0	4.6	4.0	3.2	2.4	1.6
Western	7.2	6.6	5.9	5.1	4.1	3.0	2.2

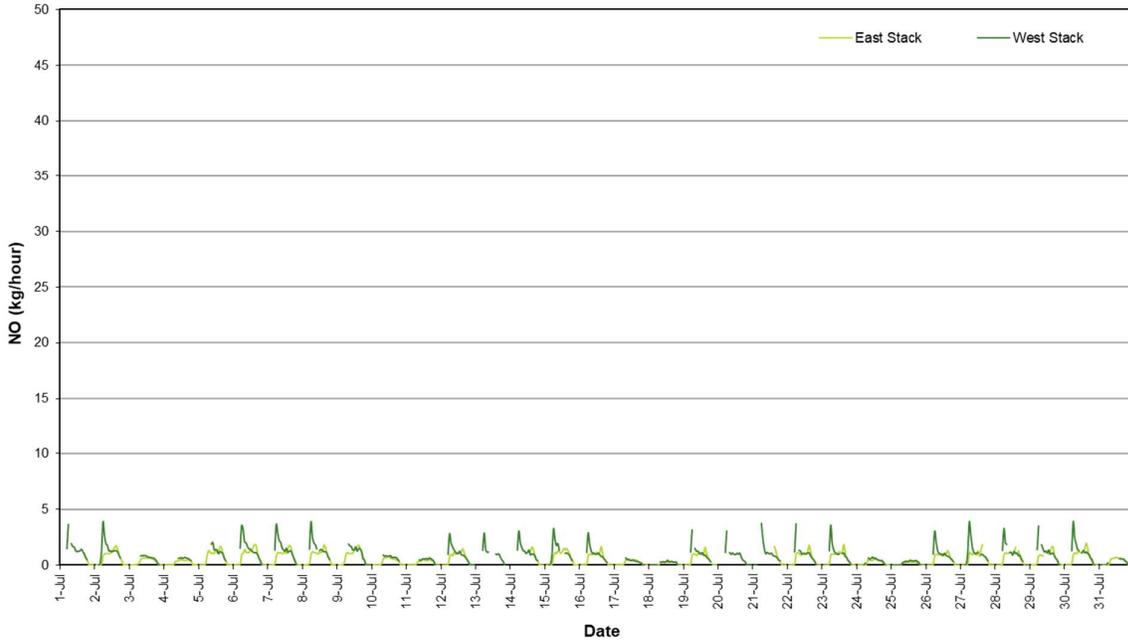
Figure 5: Nitric Oxide Mass Rate (1 Hour Average)

Nitric oxide (1 hour average) mass rate of emission statistics for the reporting period are given in Table 7. A plot of nitric oxide (1 hour average) mass rate of emission for the reporting period is presented in Figure 5.

Station	Nitric Oxide Mass Rate (kg/h) (1 Hour Average)						
	Maximum	99 th	98 th	95 th	90 th	75 th	50 th
Eastern	2.0	1.8	1.6	1.4	1.2	0.97	0.33
Western	3.9	3.8	3.6	2.7	1.9	1.3	0.88

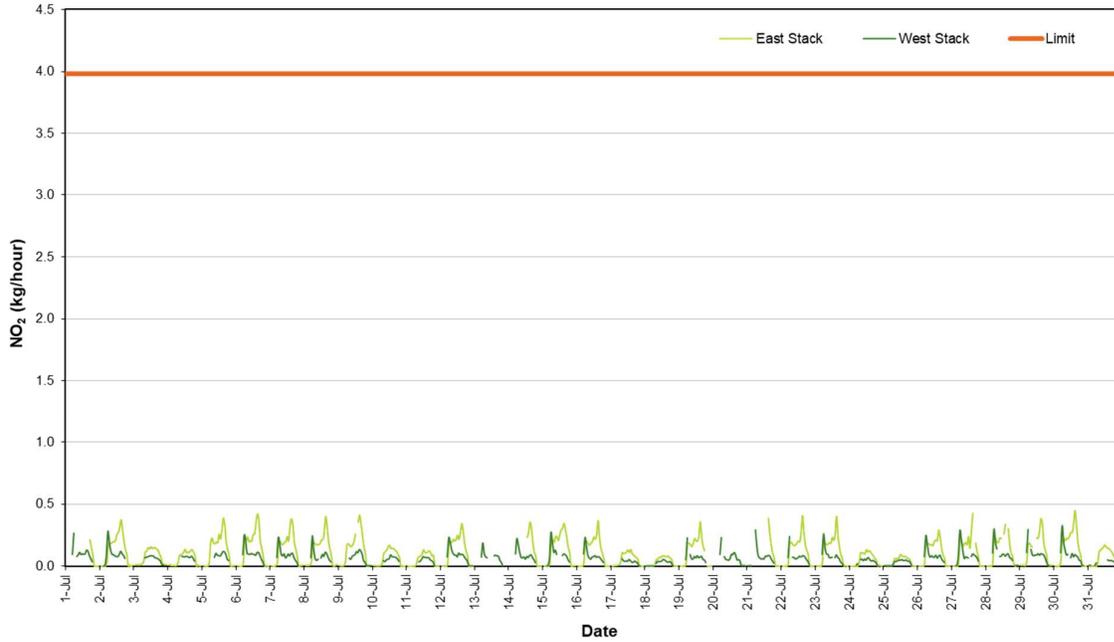
Figure 6: Nitrogen Dioxide Mass Rate (1 Hour Average)

Nitrogen dioxide (1 hour average) mass rate of emission statistics for the reporting period are given in Table 8. A plot of nitrogen dioxide (1 hour average) mass rate of emission for the reporting period is presented in Figure 6.

Station	Nitrogen Dioxide Mass Rate (kg/h) (1 Hour Average)						
	Maximum	99 th	98 th	95 th	90 th	75 th	50 th
Eastern	0.45	0.39	0.37	0.30	0.24	0.19	0.086
Western	0.32	0.28	0.25	0.19	0.12	0.091	0.069

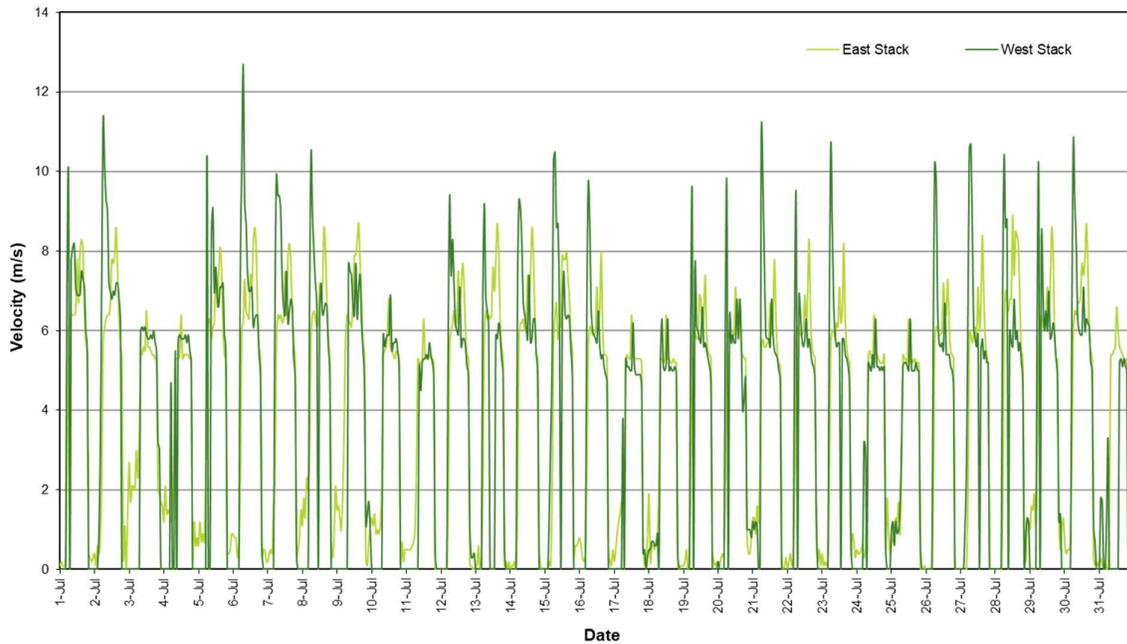
Figure 7: Stack Velocity (1 Hour Average)

The stack velocity (1 hour average) plot for the reporting period is presented in Figure 7.

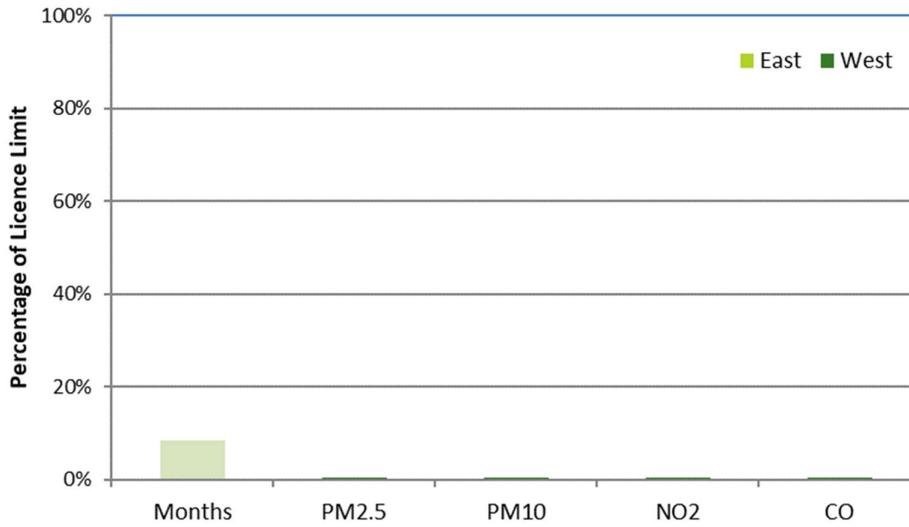
Figure 8: Ventilation Stack Emissions as Percentage of Licence Limit (1/07/2021 – 31/07/2021)

Station	NO ₂	CO	PM _{2.5}	PM ₁₀
Eastern	0.074	1.1	0.018	0.031
Western	0.037	1.2	0.016	0.033
Total	0.11	2.3	0.034	0.064
Licence limit	35	980	21	23

Figure 20 presents the ventilation stack emissions of each parameter as a percentage of the Licence limit compared with the percentage of APS reporting period elapsed.
